**Flood Control Project Maintenance
Levee Inspections**

2013 Channel Summary Report

DWR Sutter Maintenance Yard

**Flood Control Project Maintenance
Channel Inspections**

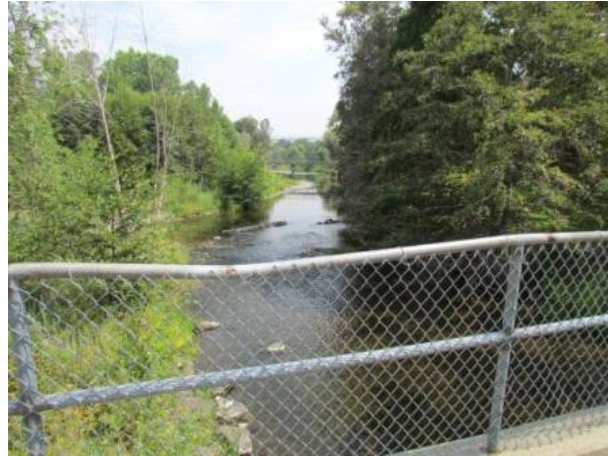
mhoffman_c_20130805_080.JPG

This is the upstream side of the structure.

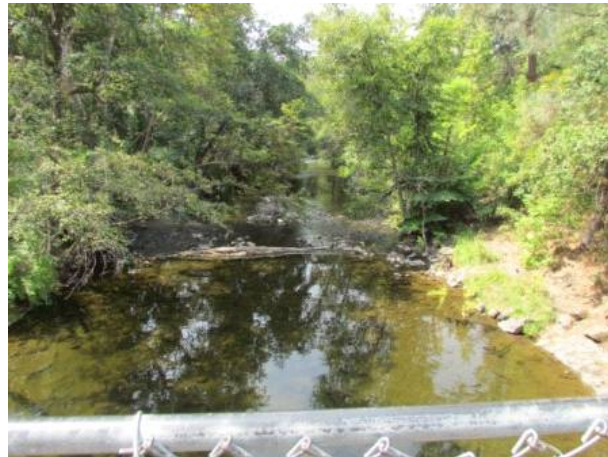
mhoffman_c_20130805_081.JPG

Downstream side of the structure.

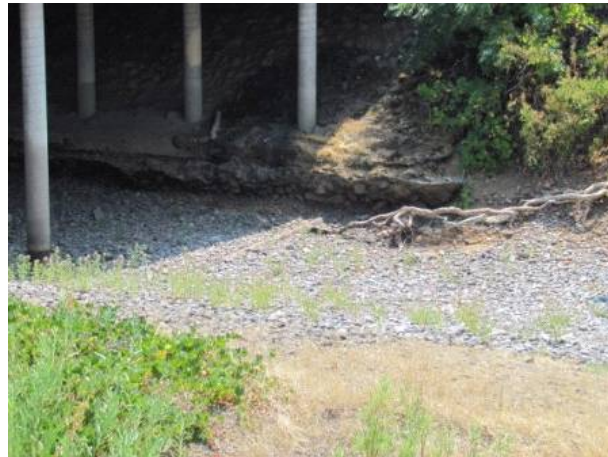
mhoffman_c_20130807_102.JPG

Levee Mile Report Line	48
Start Levee Mile	0.00
End Levee Mile	0.00
Location	
Category	Channels
Item	Erosion / Bank Caving

Erosion around bridge footing and south bank of channel.

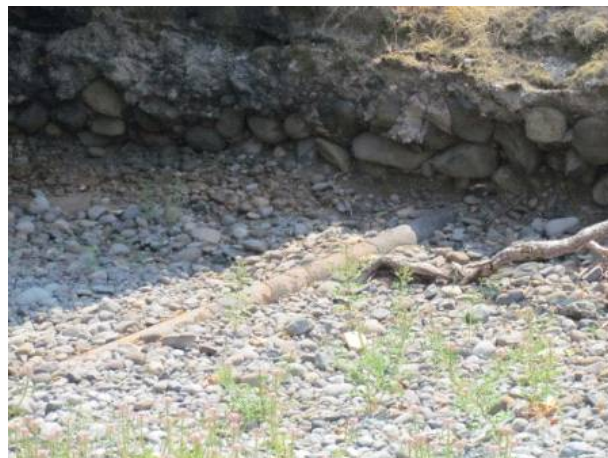
mhoffman_c_20130807_103.JPG

Levee Mile Report Line	48
Start Levee Mile	0.00
End Levee Mile	0.00
Location	
Category	Channels
Item	Erosion / Bank Caving

Erosion around bridge footing and south bank of channel.

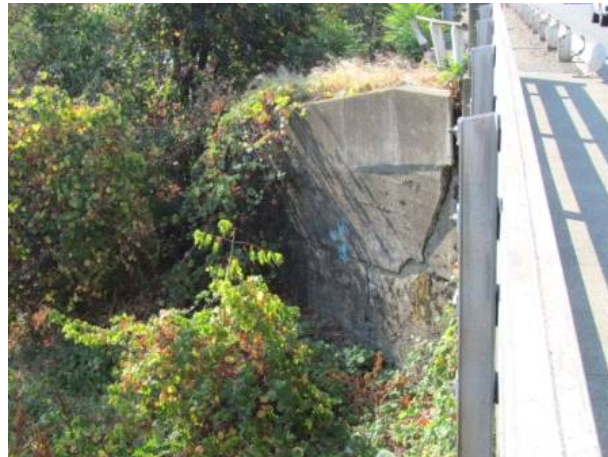
Levee Mile Report Line	51
Start Levee Mile	0.00
End Levee Mile	0.00
Location	
Category	Channels
Item	Vegetation & Obstructions
Concrete cracking on south side wing wall upstream of Esplanade Ave.	
mhoffman_c_20130807_105.JPG

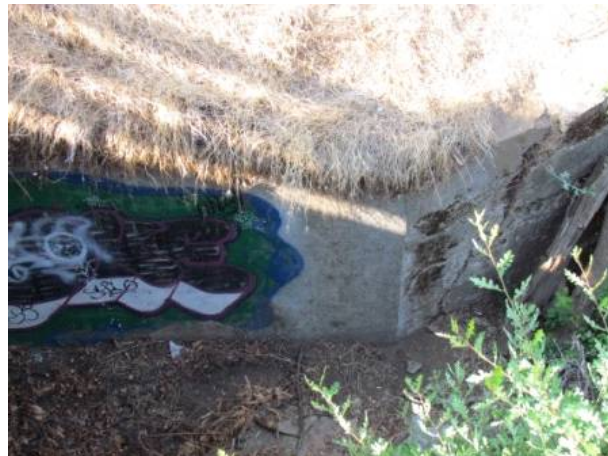
Levee Mile Report Line	56
Start Levee Mile	0.00
End Levee Mile	0.00
Location	
Category	Channels
Item	Vegetation & Obstructions
Concrete cracking on south side wing wall downstream of Esplanade Ave.	
mhoffman_c_20130807_106.JPG

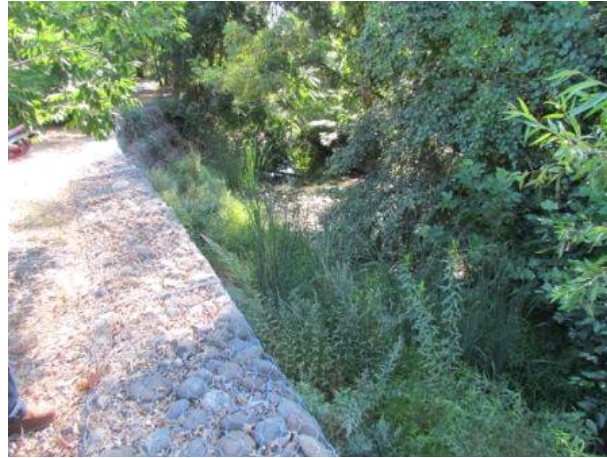
mhoffman_c_20130805_070.JPG

This photo is looking upstream at the erosion repair site, up stream from Highway 99 on Humboldt Road. There is vegetation in the channel, the flow in the channel does not appear to be impeded.

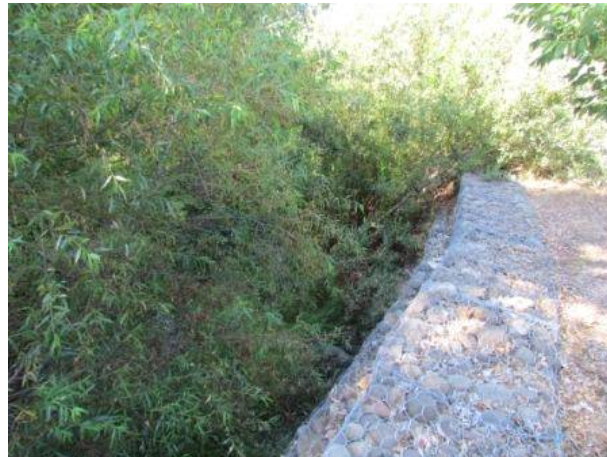
mhoffman_c_20130805_071.JPG

This photo is looking downstream at the erosion repair site, down stream of Highway 99 on Humboldt Road. There is vegetation in the channel, the flow does not appear impeded.
